**Tenmile River Assessment**
Shoreline Survey and Action Plan
January 2006

Tenmile River Stream Team Report

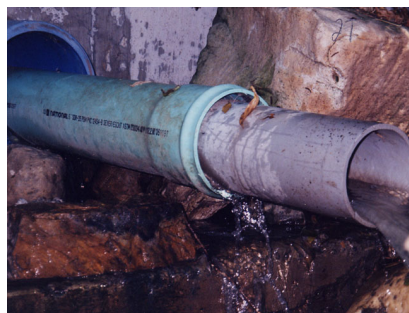
Pipe discharging by Woodwinds

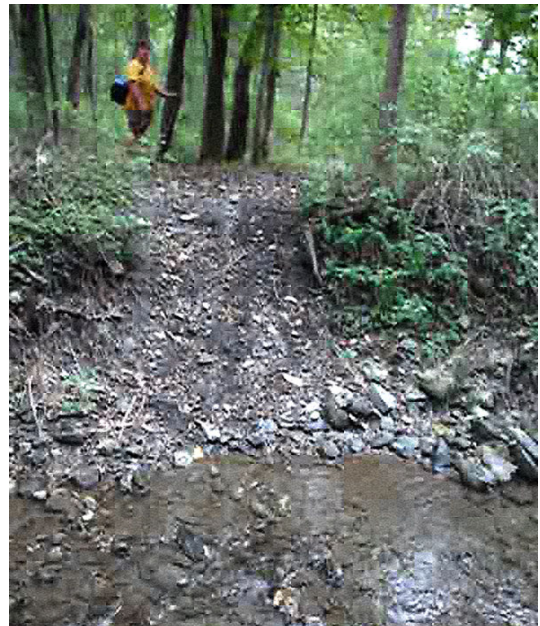
The end of the segment is near a small tributary on State property known as the Wassaic Multiple Use Area. ATV tracks were observed traversing this area and causing negative impacts on the riparian zone and the river.

ATV tracks leading into tributary

- Discourage littering.
- Monitor sewage outlet.
- Encourage railroad to repair riparian zone near tracks.
- Educate, monitor and regulate ATV users.

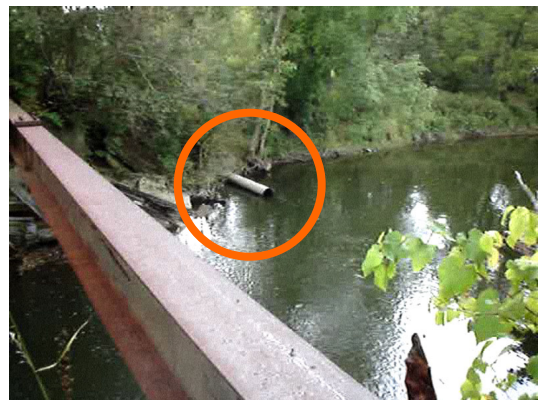
DDSO. It has a large discharge pipe that enters the river near a damaged bridge that is falling into the river. Litter was common throughout this section.

Discharge pipe by Taconic DDSO

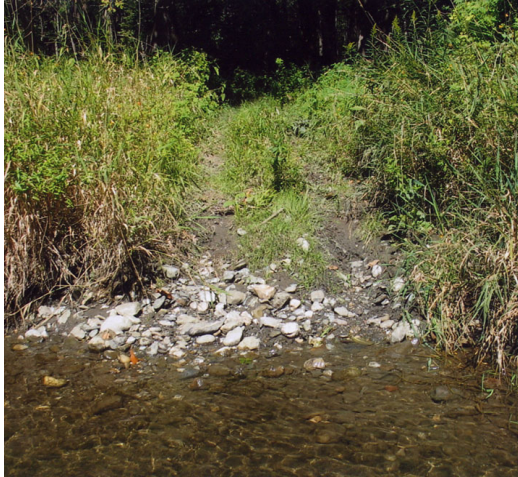
Stream bank stability is threatened in many places by extensive ATV use. This is especially apparent near the end of this segment where Oak Drive allows for easy river access. A motorcycle track and a closed construction-and-demolition site are located near the Oak Drive area. It is evident that motorcyclists ride from the track onto sandbars along the river's edge.

ATV crossing, one of many on the river

- Educate and regulate ATV users.
- Educate homeowners on importance of riparian zone.

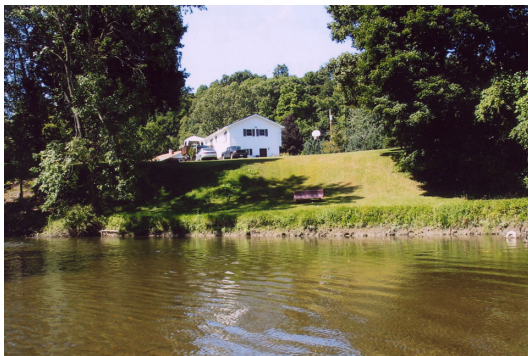
Some homeowners have cleared or mowed their property down to the edge of the river. The riparian zone was seriously compromised in this area. Dumping was also observed, including large items like abandoned cars.

Mowing to the river's edge

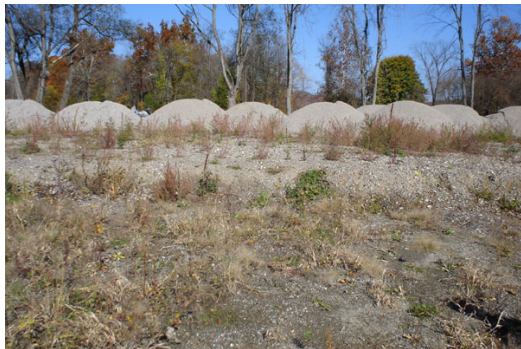
The most serious impairment on the entire river is in this segment. Tenmile River LLC, off of Midfield Lane north of Dover Plains, has covered several acres of this property with construction-and-demolition debris. This has obliterated a wetland and spilled over silt fences down into the river. The debris was tested by the Town of Dover and found to contain mesityl oxide, a compound known to be toxic to aquatic life. This material is leaching into a small stream that leads into the Tenmile. The Town of Dover is currently seeking remediation of this site in order to

Piles of construction and demolition debris along the river's flood plain

- Monitor dumpsites.
- Regulate ATVs.
- Initiate clean-ups.
- Support town efforts to remediate Tenmile River LLC site.

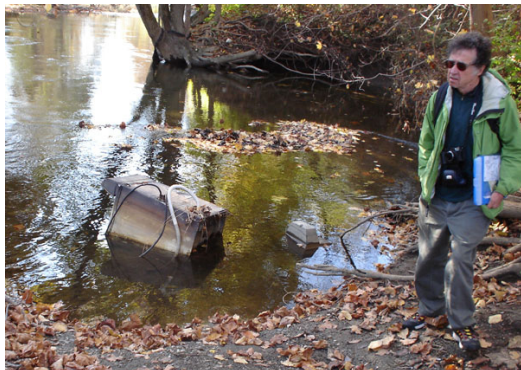
Trash dumped in the river near Dover Plains

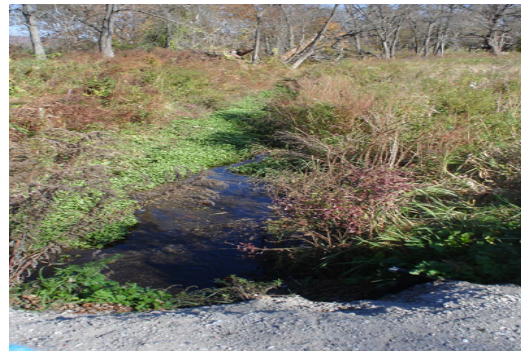
The most severe impairment found along the river is a large illegal construction-and-demolition dump called Tenmile River LLC. The waste, tested by the Town of Dover, was found to contain mesityl oxide, a chemical toxic to aquatic organisms. This site is currently under investigation and enforcement for non-compliance by the New York State Department of Environmental Conservation and the Town of Dover. Two other areas of concern that need further assessment are a dumpsite south of the railroad bridge near the C&D waste site and a pipe located near Westchester Modular Homes that was observed to be discharging a foul odorous white liquid into the river.

Mesityl oxide leaching into Tenmile tributary

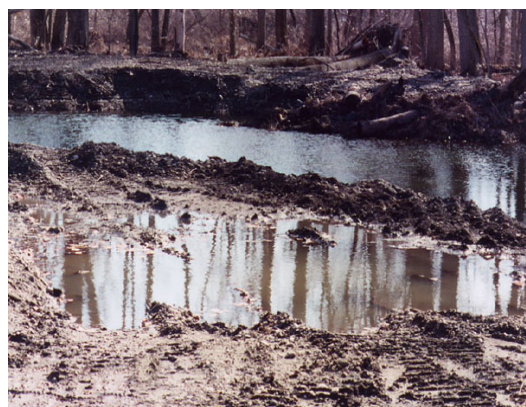
Construction along the Swamp River

- Clean up trash.
- Regulate ATVs.
- Alert DEC and Town government of dumping.
- Pursue cessation of silt and construction deposits with the Town located at the mouth of Swamp River.

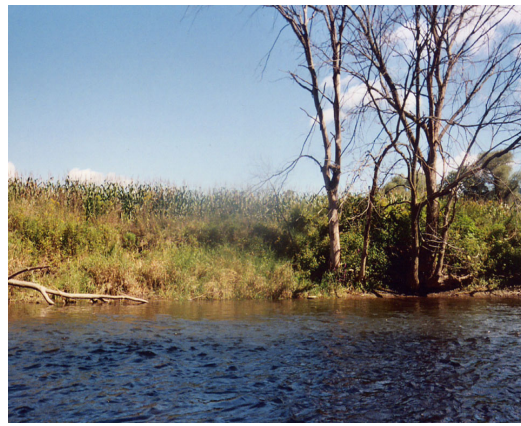
Cornfield close to the river

- Move agricultural zones back from the river.
- Close crossings.
- Restore riparian zone.
- Explore and monitor for lead impacts along the river.

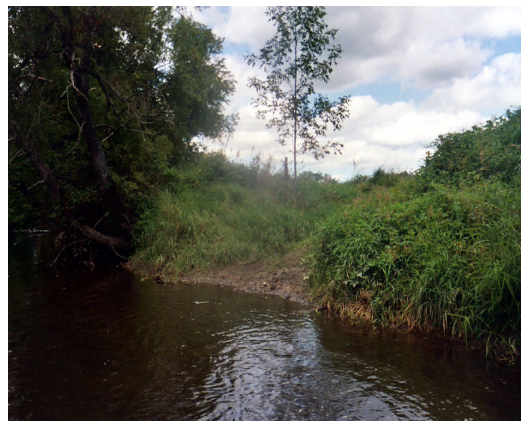
Farm road entering the river

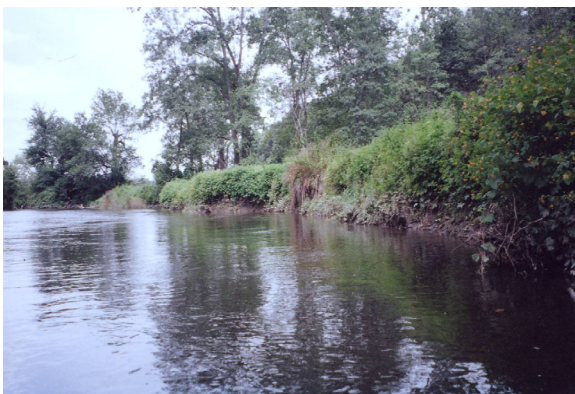
* Invasive plants observed included purple loosestrife, Russian olive, Oriental bittersweet, bush honeysuckle, Eurasian water milfoil, Japanese barberry, knapweed, multi-flora rose and garlic mustard.

Invasive species in riparian zone

- Monitor river for contamination.
- Control invasive species.
- Explore potential of lead contamination.

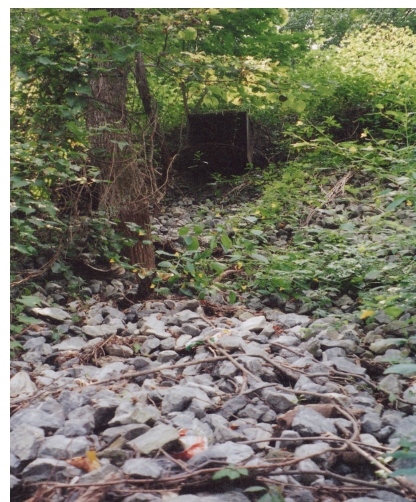
Dutchess County Route Six travels closely along the western side of the stream shore. Here, a large culvert with extensive rip-rap drains into the river. Whitish-brown foam was present. Evidence of bank erosion was more common in this segment.

Culvert off of Rte. 6

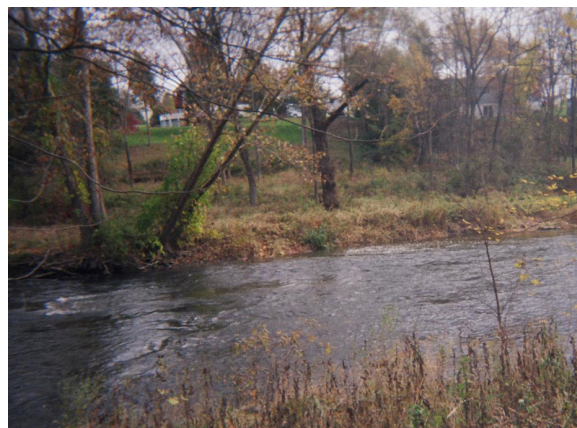
In a few places, homeowners have cut down trees in the riparian zone and have mowed down to the edge of the river. This is a common practice along most of the river and could be remedied by an education program for riparian zone restoration. The cutting is probably to improve the residents' view of the river.

Riparian zone mostly mowed down

- Restore riparian zone.
- Clean up along road.
- Educate homeowners on importance of riparian zones.

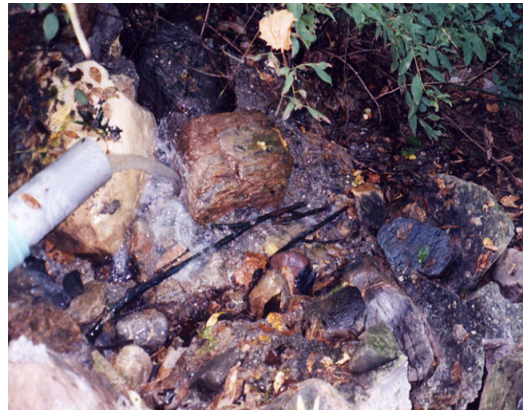
east bank. There is a large buffer zone between the river and these two areas, but a sewage disposal outflow pipe enters the stream at this point. This is a permitted use discharging a significant flow that has been observed to be murky, cloudy and odiferous. In the same area a milky liquid was observed entering the river from below the surface. Its origin was not determined.

Sewer outfall

- Clean up trash.
- Monitor sewer.
- Restore riparian zone.

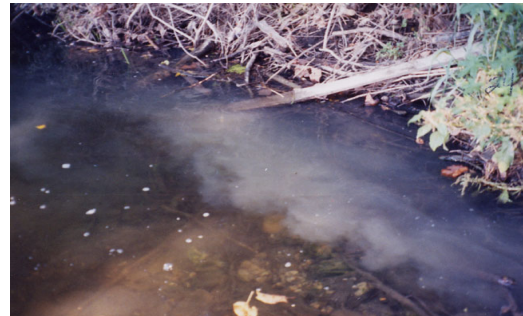
Murky discharge

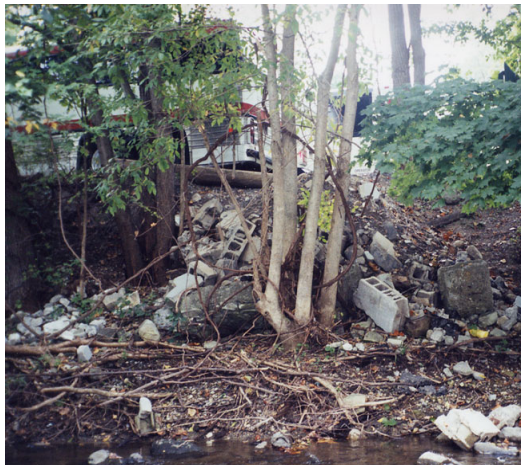
The riparian zone on the western bank has been mowed to the river and a bus garage parking lot impinges on the banks. Litter and debris along with a drainage pipe were found here.

Bus garage and trash
